Manhole Inspection Summary

Manhole # S45E__025MH

Record Plat: **45E** Node: **025** Status: **Found**

Insp Date: **7/23/08 9:41 AM**

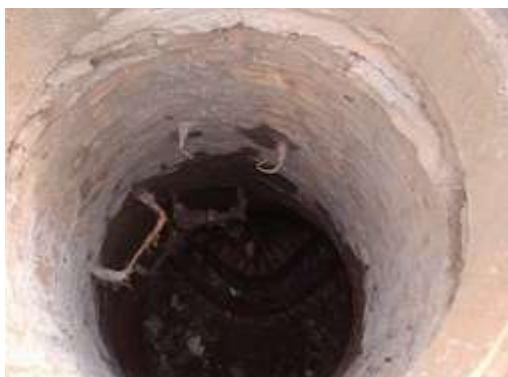
Defect 1

☒ **Leaks**

Frame Leaks

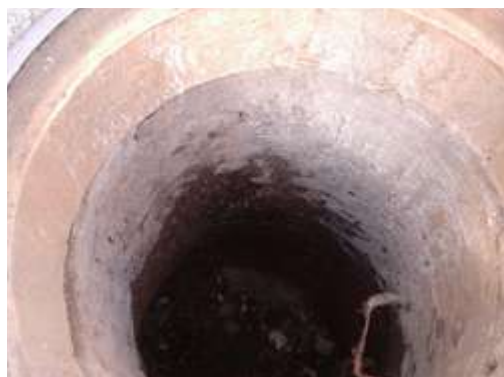
Defect 2

Infiltration: ☐ None ☒ **Joint** ☐ Cracks ☒ **Mortar** ☐ Roots ☐ Wall

Infiltration

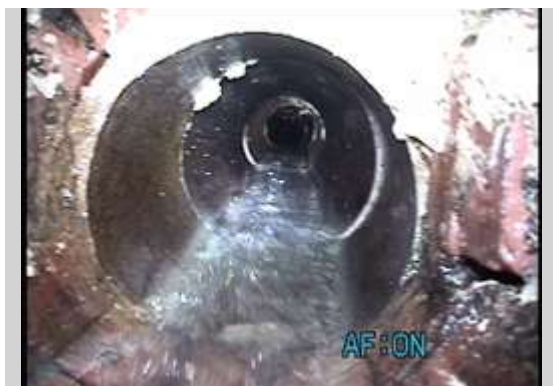
12 O'Clock Outflow

8 in. Circular Gravity Sewer
Pipe Out @ 12 O'Clock

Pipe Height: **8.4** (in.) Rod and Bar (Angled)
Pipe Material: **Clay** ☐ Pipe Lined
Invert Depth: **10.05** (ft.) Flow Characteristics: **Fast**
Deposits: ☒ None ☐ Mud ☐ Sludge ☐ Debris ☐ Grease
Silt Depth: (in.) Deposits Extent:
Infiltration: **None** Pipe Seal Cond: **Sound**

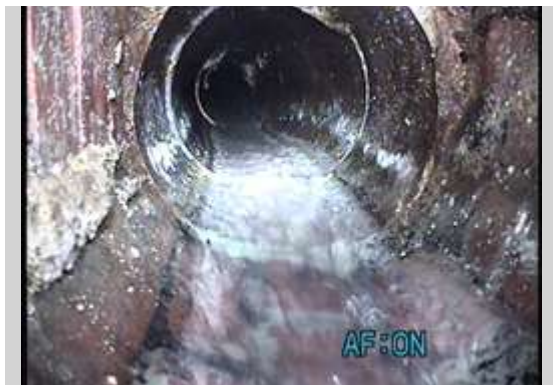
3 O'Clock Inflow

8 in. Circular Gravity Sewer
Pipe In @ 3 O'Clock

Pipe Height: **8.4** (in.) Rod and Bar (Angled)
Pipe Material: **Clay** ☐ Pipe Lined
Invert Depth: **9.90** (ft.) Flow Characteristics: **Fast**
Deposits: ☒ None ☐ Mud ☐ Sludge ☐ Debris ☐ Grease
Silt Depth: (in.) Deposits Extent:
Infiltration: **None** Pipe Seal Cond: **Sound**
